Building Inspection Report

16355 Juanita Drive NE, Kenmore, WA

5/6/2008

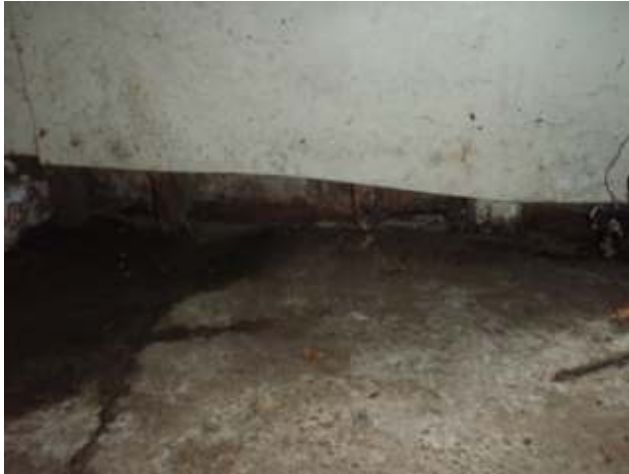
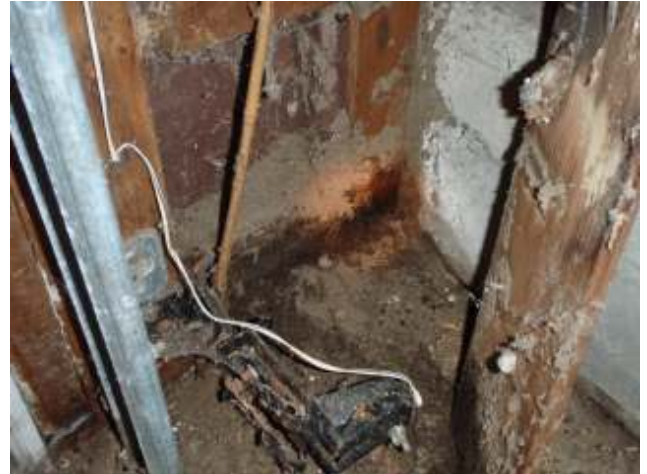
- **Major Concern:** More extensive wall damaged from rot and insect activity was observed on the west wall of the garage on both sides of the overhead garage door. All damaged wood should be removed and the area should be treated as necessary for all wood destroying organism and new pressure treated wood should be installed. Ideally, the exterior wall would be framed on top of a concrete stem wall, not directly on the garage slab. Further review by a qualified contractor is recommended.

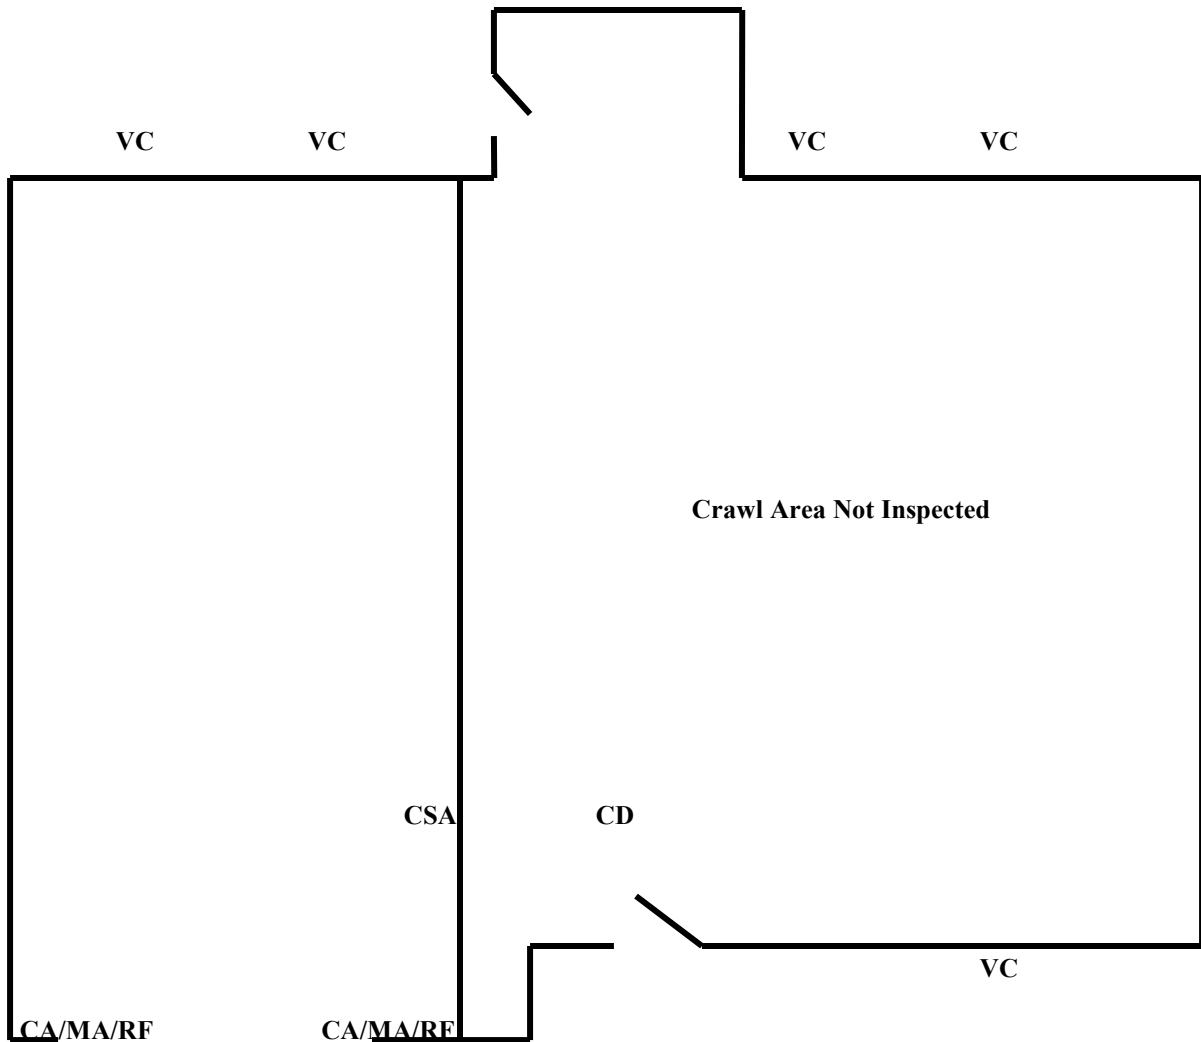
- **Major Concern:** Evidence of Moisture Ant activity and/or damage was present in the home. (See Sketch) In most cases, removal and/or replacement of infested wood combined with the elimination of the excessive moisture condition are sufficient for the control of Moisture Ants. It is deemed necessary by this inspector that the infested area also be treated for the control of Moisture Ants with an EPA approved material. Treatment is to be performed by a Washington State licensed applicator. Treatment shall conform to current industry standards. Applicator shall provide a written one-year warranty against re-infestation. It is recommended that a structural engineer or contractor specializing in these types of repairs be consulted to further evaluate the condition of the structure to determine what wood has been compromised and the remedies available for correction.

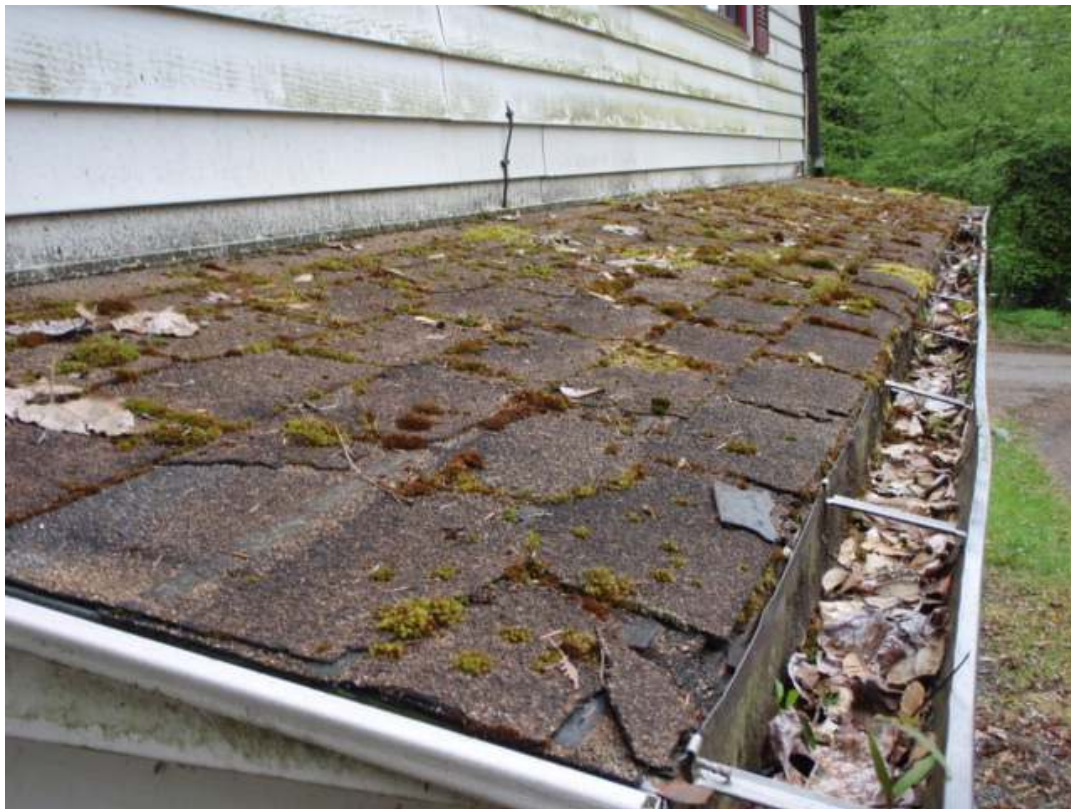
- **Repair:** The roofing is near the end of its life. Minor repairs might be possible to extend the roof life and to defer leaks. Damaged or missing roofing material should be repaired. All roof penetrations should be examined and sealed as necessary. Expect to replace the roof soon.
- **Repair:** The lower north roof over the sidewalk needs to be replaced immediately.

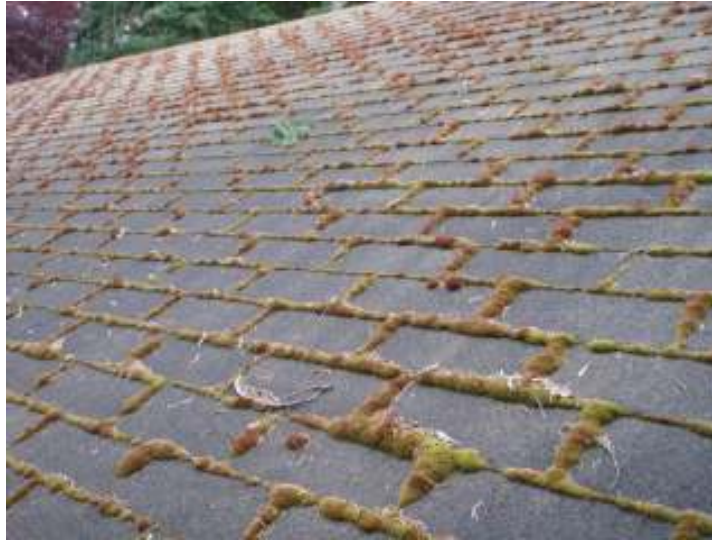
- **Repair:** The roofing shows evidence of moss and organic build up in heavily shaded areas. This condition may influence the life expectancy of the roofing. It is recommended that all moss and tree debris be removed from the entire

roof with a chemical treatment or compressed air by a roofing professional. Pressure washing this type of roof will cause pre-mature damage to the shingle.

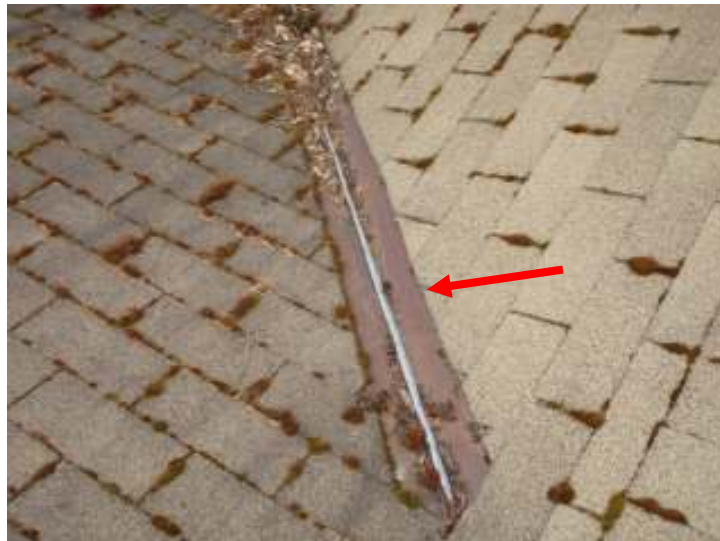
- **Repair:** The flashings in many locations are rusting. They should be painted to extend its life.

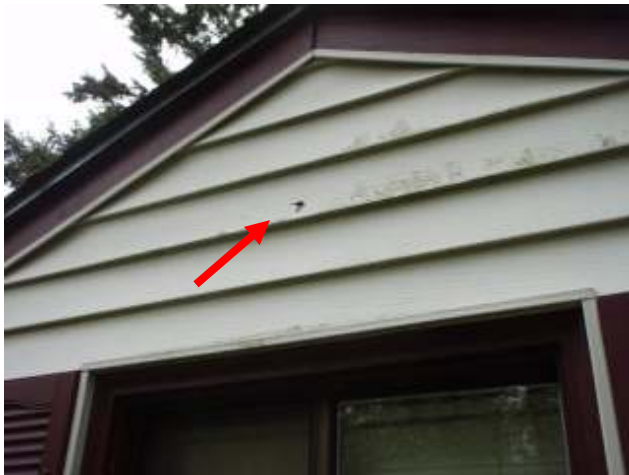
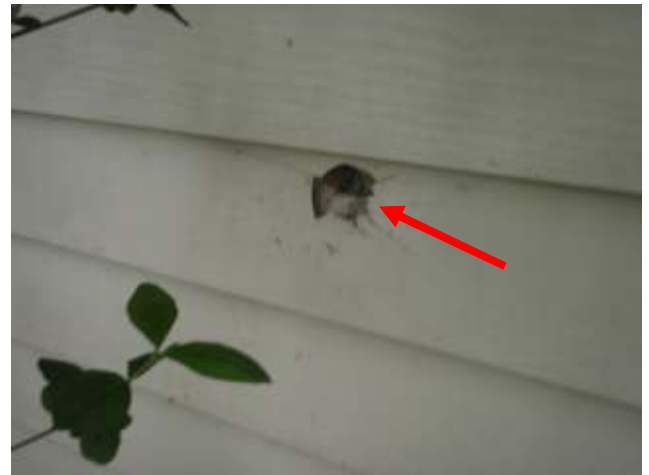
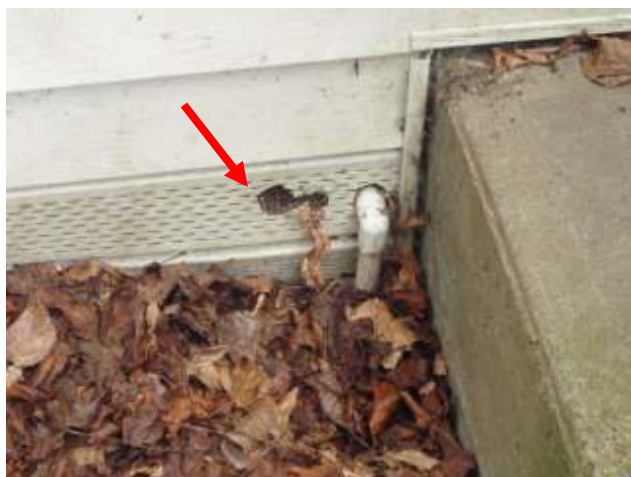
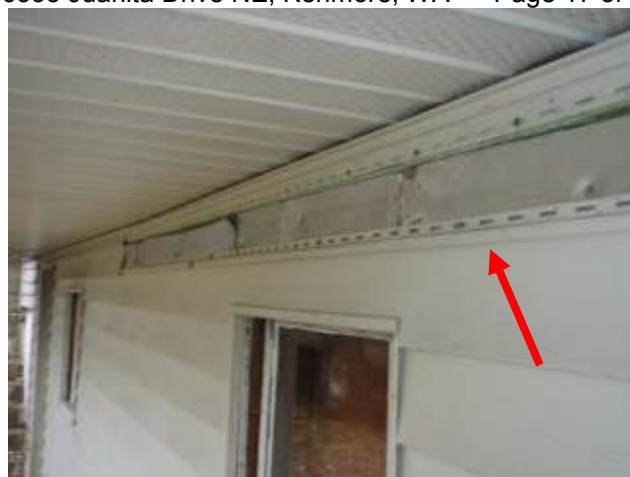
- **Repair:** The loose or damaged siding in many locations should be re-secured or repaired to avoid moisture intrusion. Further review by a qualified vinyl siding expert is recommended.

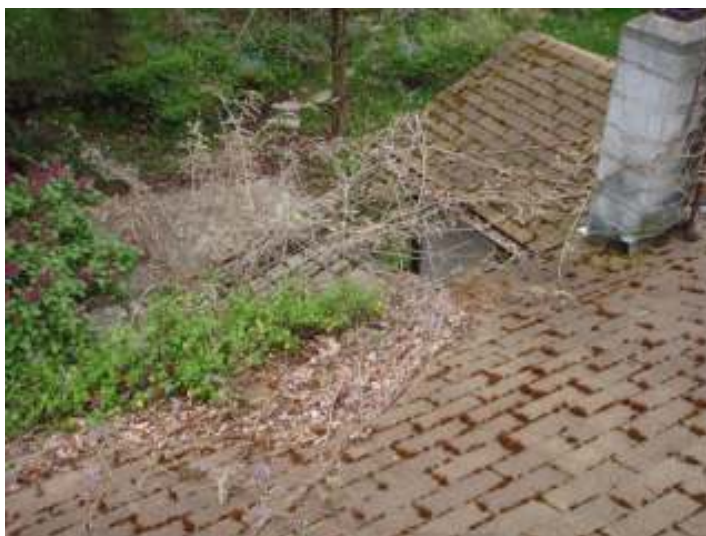
- **Repair:** Vines growing on exterior walls at the east side of the home should be kept trimmed away from siding, window trims, and the eaves to reduce risk of insect and water damage.

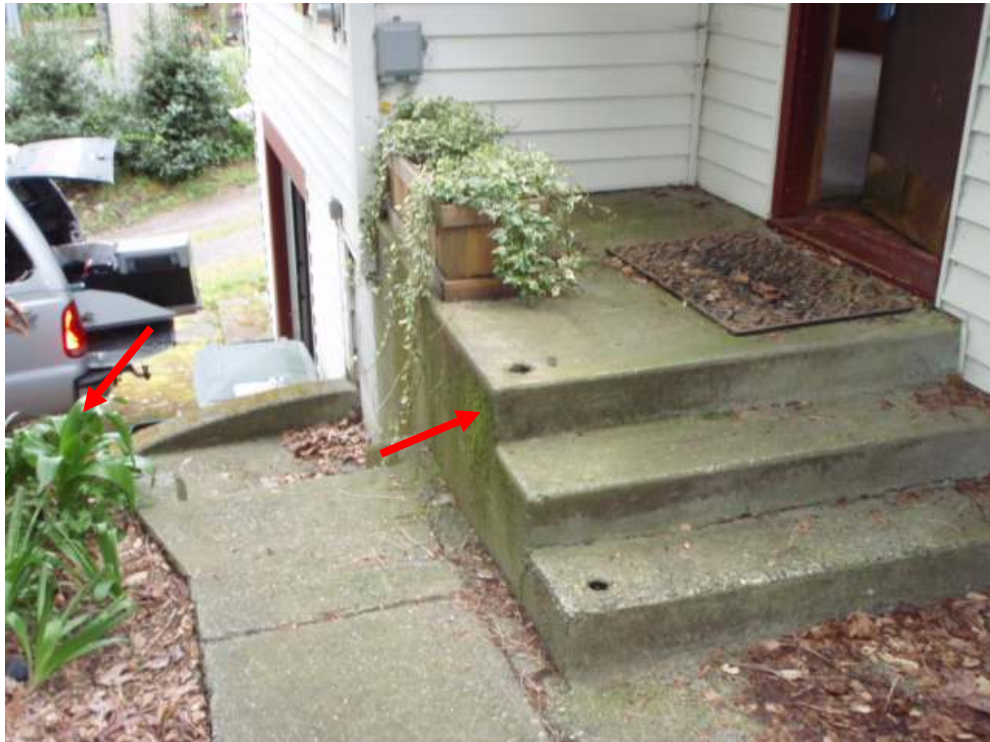
- **Repair, Safety Issue:** A railing should be provided for both sets of steps at the west side of the home.

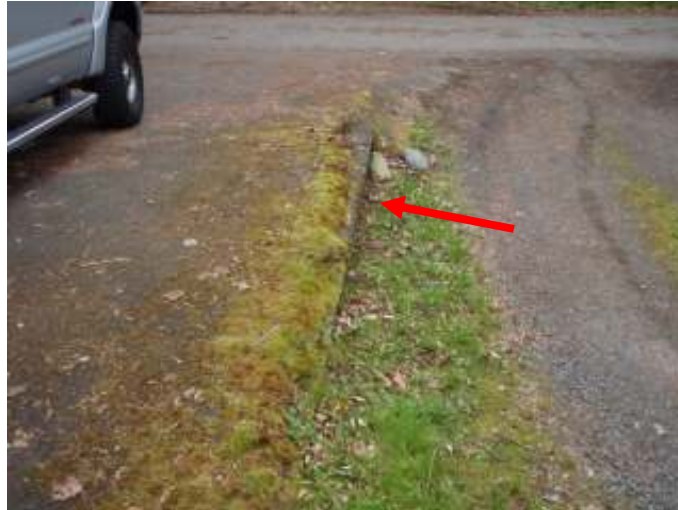
- **Repair:** The north side of the driveway could prove to be a hazard. There is a partial railroad tie that was installed.

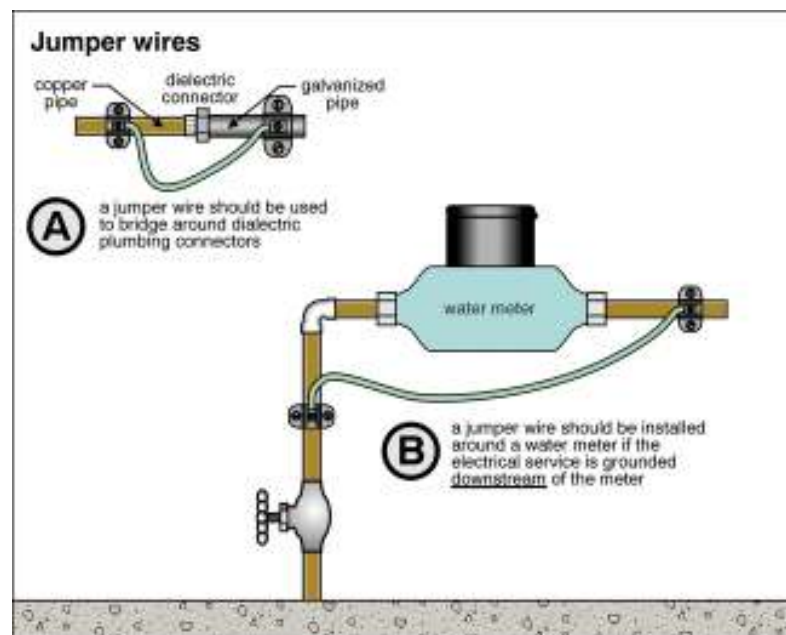
- **Repair:** The hot and cold water line needs to be properly bonded together at the water heater location. A licensed electrician should investigate this.

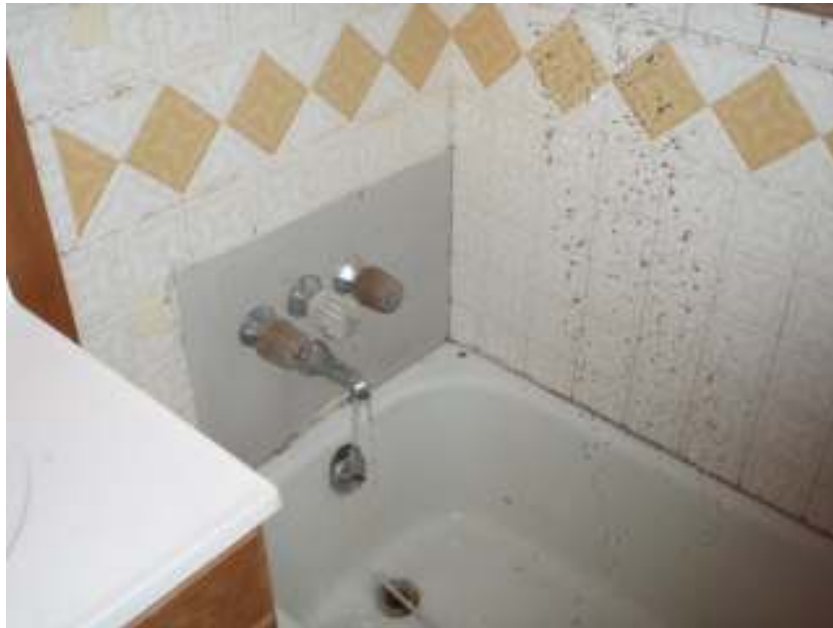
- **Repair:** The bathtub enclosure should be rebuilt. Wall damage behind the enclosure should also be repaired.

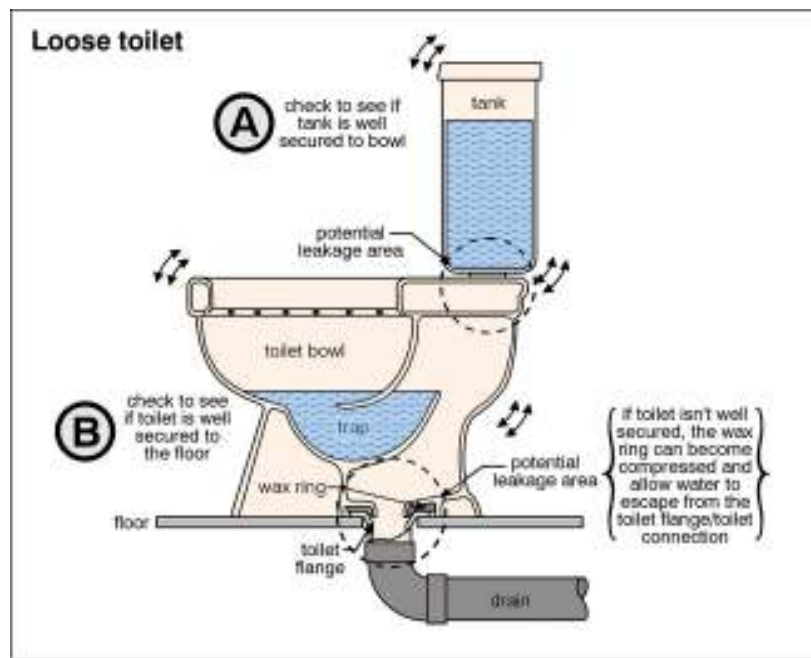
- **Repair:** The window and sill of the bathtub enclosure should be protected from moisture. A waterproof curtain is usually sufficient. Windows in bathtub enclosures have a reputation for allowing leakage behind the enclosure, causing damage to the wall.
- **Repair:** An exhaust fan that discharges to the building exterior is recommended in the main bathroom.
- **Repair:** It is recommended that an anti-siphon device be added to the hose bib(s).
- **Repair:** The toilet in the main bathroom is loose. Remove toilet and replace any damaged material that may be present. High moisture readings were noted around the base of the toilet with a non-invasive moisture meter. Dry out or replace floor and reinstall toilet onto a new paraffin wax seal. Test to make sure that toilet is secured and does not leak.
