HOME INSPECTION REPORT

Anywhere
Madison, WI 53704

Inspection Date:
2007

Prepared By:
A-Pro Home Inspection Services
6372 Nesbitt Road
Madison, WI 53719

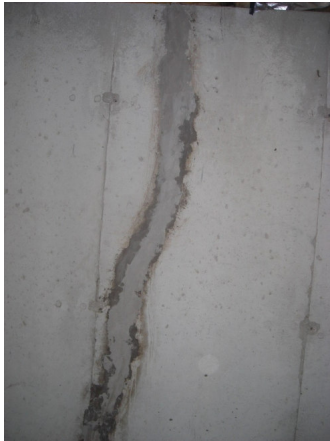
- **Monitor:** Slightly greater than typical foundation cracking was observed. Prior repairs were noted to the foundation. Patched/sealed cracks were visible on both sides of home. These areas should be monitored. The rate of movement cannot be predicted during a one-time inspection.

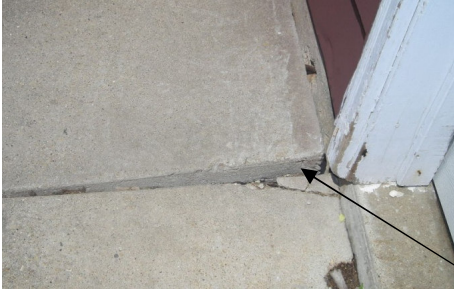
- **Safety Issue:** The walkway presents a trip hazard. The sidewalk was sloped, which could be a slippery areas in colder months, or a potential trip issue. This condition should be altered for improved safety.

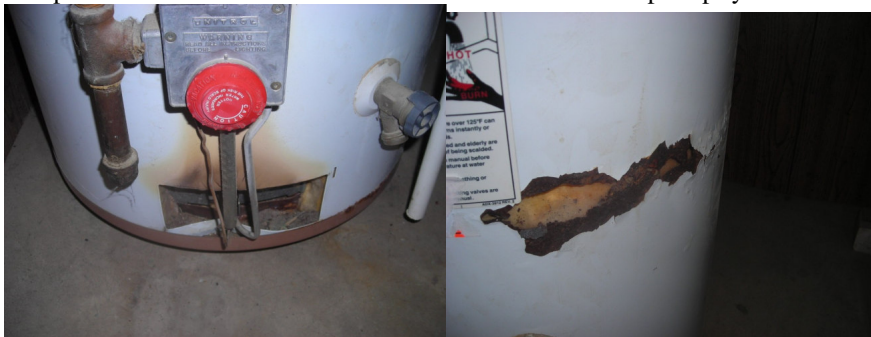
- **Major Concern:** Recommend replacement of the water heater. A large slice with rust was on unit (see photo). There is also evidence of back drafting. See photo, as well as additional information under Heating section. The water heater venting system shows evidence of exhaust “spillage”. This is a serious condition that could be a health hazard to the occupants of the home. This condition should be addressed promptly.

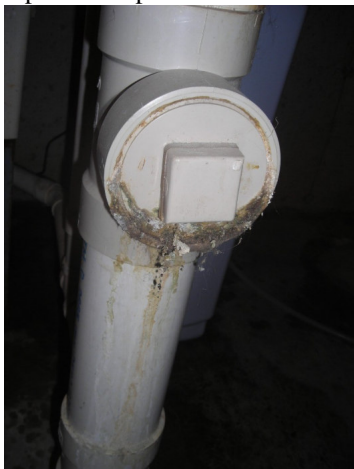
-
- **Major Concern:** Evidence of leakage was visible at waste clean out area adjacent to basement stairs. Recommend repairs. See photo below.

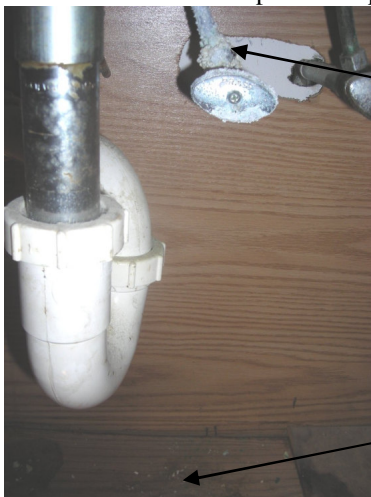
-
-
- **Major Concern:** The shut off handle under bathroom sink was highly corroded, wet, and had leakage evidence inside the cabinet. Recommend repairs. See photo.

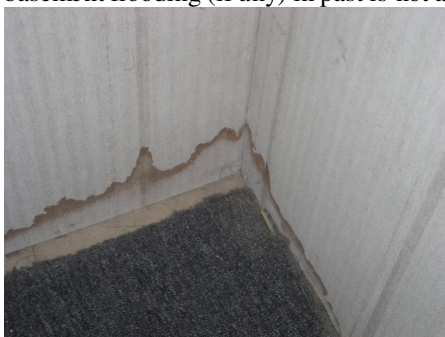
- **Monitor/Improve:** Water staining was noted in basement on interior walls. See photo. No signs of recent standing water were present in basement. Some walls have been replaced, while other paneled walls were warped. Drain back ups or basement flooding (if any) in past is not able to be reported on during this visual inspection.
