HOME INSPECTION REPORT

Anywhere
Madison, WI 53704

Inspection Date:
2007

Prepared By:
A-Pro Home Inspection Services
6372 Nesbitt Road
Madison, WI 53719

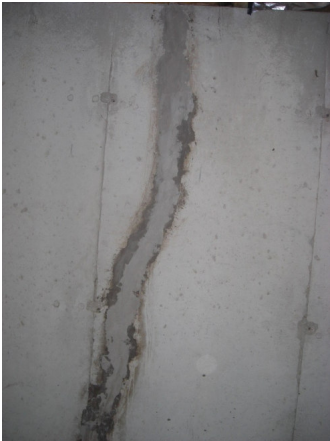
- **Monitor:** Slightly greater than typical foundation cracking was observed. Prior repairs were noted to the foundation. Patched/sealed cracks were visible on both sides of home. These areas should be monitored. The rate of movement cannot be predicted during a one-time inspection.

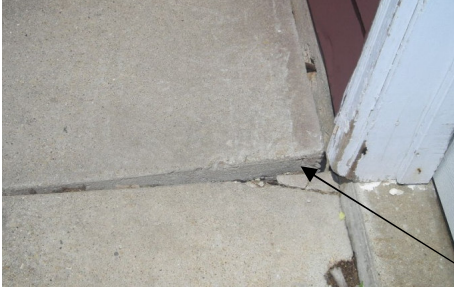
- **Safety Issue:** The walkway presents a trip hazard. The sidewalk was sloped, which could be a slippery areas in colder months, or a potential trip issue. This condition should be altered for improved safety.

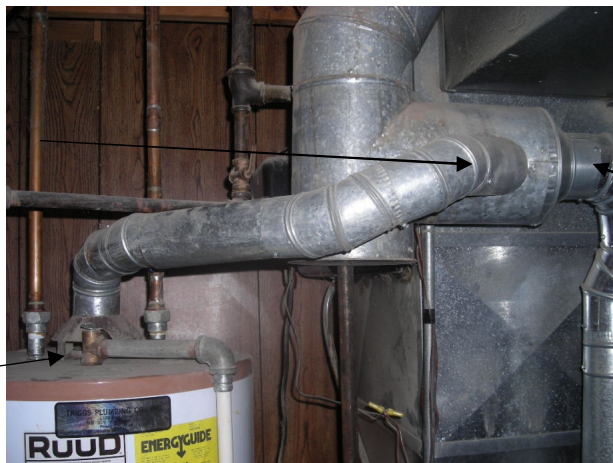
- **Safety Issue:** The heating system shows evidence that exhaust products have been “back drafting” at the water heater. *This is a health concern.* This condition may be the result of inappropriate flue and chimney configuration. It appears that the furnace exhaust may be discharging through the water heater areas. See photo. Also see photo under Plumbing section. A qualified licensed heating technician should be consulted. Poor exhaust flue connections should be improved immediately.

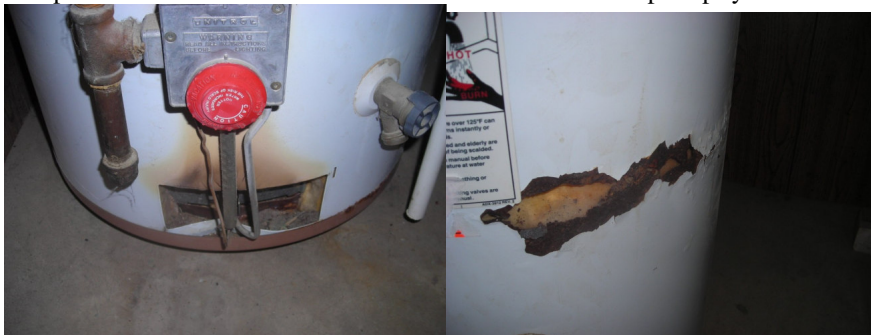
- **Major Concern:** Recommend replacement of the water heater. A large slice with rust was on unit (see photo). There is also evidence of back drafting. See photo, as well as additional information under Heating section. The water heater venting system shows evidence of exhaust “spillage”. This is a serious condition that could be a health hazard to the occupants of the home. This condition should be addressed promptly.

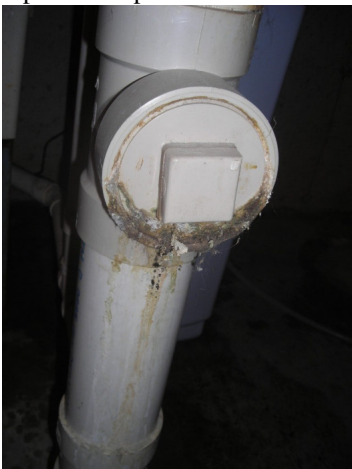
-
- **Major Concern:** Evidence of leakage was visible at waste clean out area adjacent to basement stairs. Recommend repairs. See photo below.

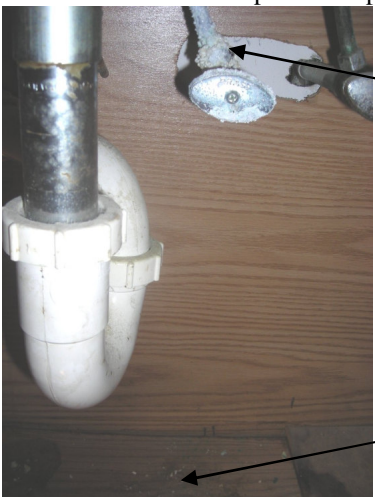
-
-
- **Major Concern:** The shut off handle under bathroom sink was highly corroded, wet, and had leakage evidence inside the cabinet. Recommend repairs. See photo.

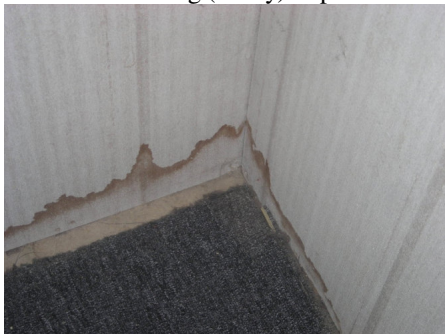
- **Monitor/Improve:** Water staining was noted in basement on interior walls. See photo. No signs of recent standing water were present in basement. Some walls have been replaced, while other paneled walls were warped. Drain back ups or basement flooding (if any) in past is not able to be reported on during this visual inspection.
