HOME INSPECTION REPORT

1234 Ocean Parkway
East Hampton, NY 11937

Inspection Date:
6/26/2008

Report Number:
00525

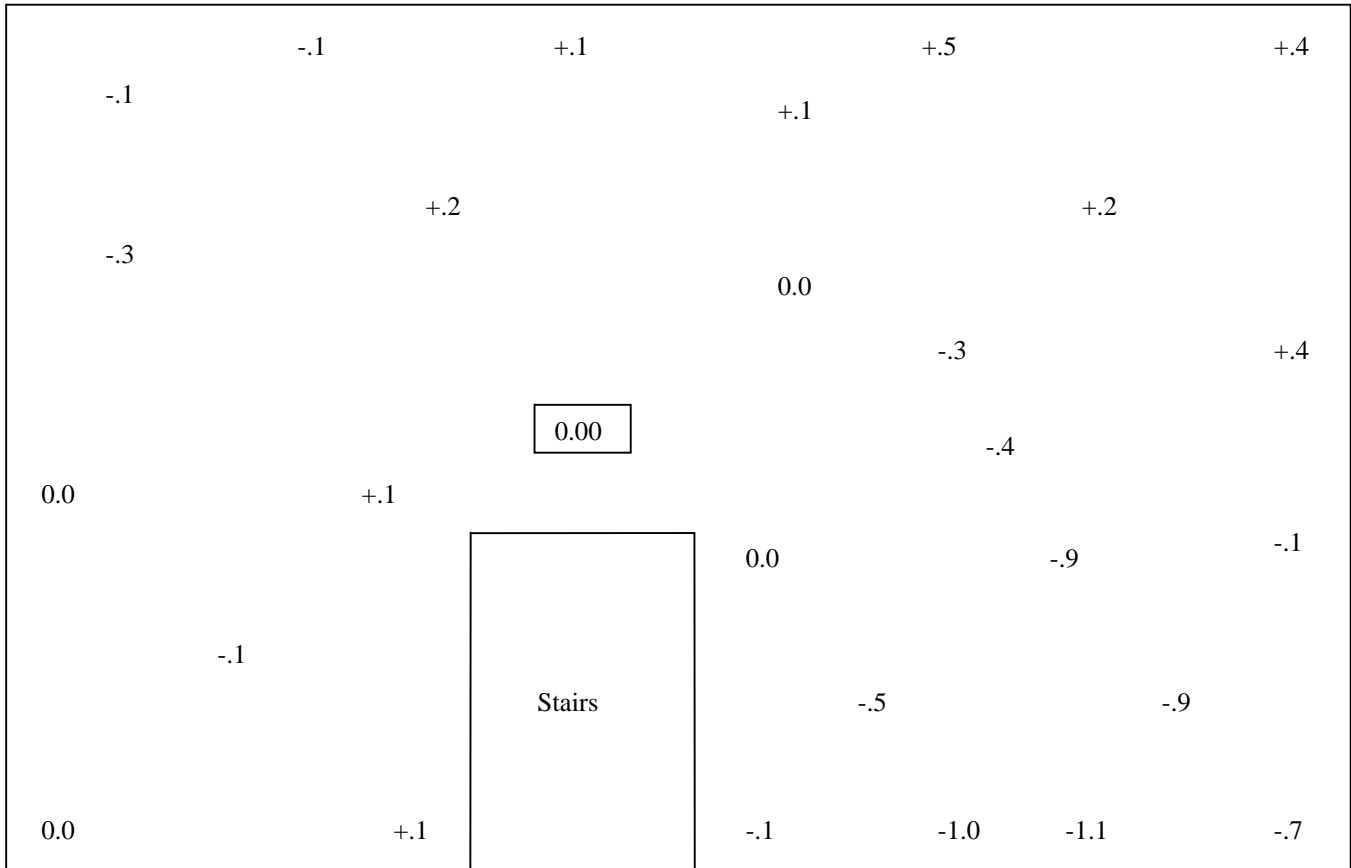
ELEVATION SURVEY

The building exhibits no evidence of substantial structural movement. A foundation elevation differential of 1.6 inches was recorded on the main structure (refer to Elevation Survey). This is within normally acceptable tolerances for a home of this age and location. No prior roof leaks were observed on the underside of the roof sheathing.

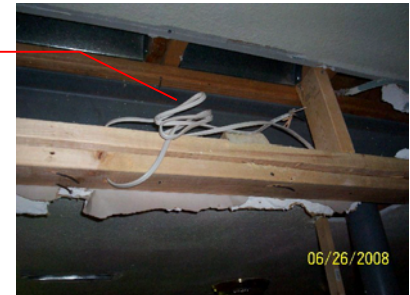
- **Improve:** The lights are inoperative in various locations. If the bulbs are not blown, the circuits should be investigated.
- **Monitor:** Evidence of remodeling or modification to the electrical system was evident. No inspection sticker was found for the electrical panel. Inquire with the owner as to the nature and any permits that may have been necessary. Evaluation of permits, identifying the extent of modifications and code compliance are beyond the scope of this

inspection. Electrical connections that may be hidden behind ceiling and wall finishes in the basement remodeling area should be investigated.

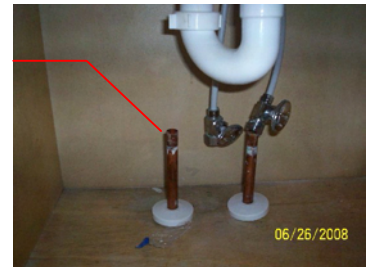
- **Monitor:** The waste piping that is exposed in the garage shows evidence of prior leakage and repair..
- **Monitor:** No trap was observed below the basement shower and basement bar. Traps serve to prevent sewer gases from entering the home.
