HOME INSPECTION REPORT

246 Easy St. Anytown, USA 15001

Inspection Date:
09/20/2007

Report Number:
07110

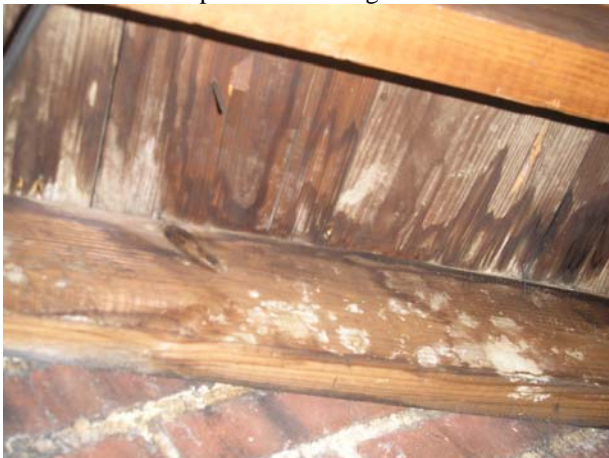
- **Monitor:** Evidence of prior roof leakage was observed around chimney in the attic.

- **Monitor:** The flashing around chimney should be carefully monitored. The proximity and configuration of this flashing is extremely vulnerable to leakage.

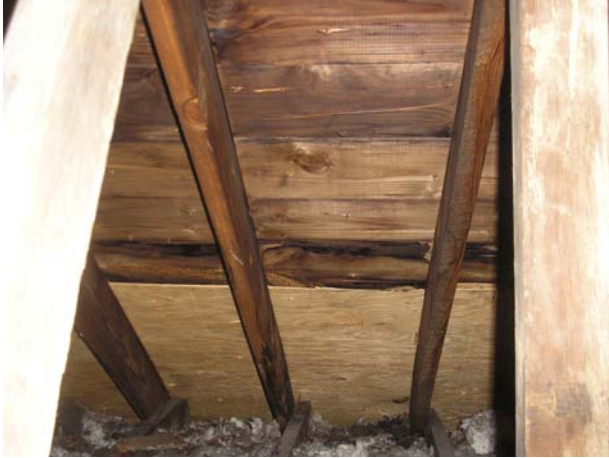
- **Monitor:** Prior repairs to the roof structure (plywood sheathing) are evident in the attic. It may be wise to consult the current owner regarding their knowledge of the roof structure and/or any repairs that became necessary.

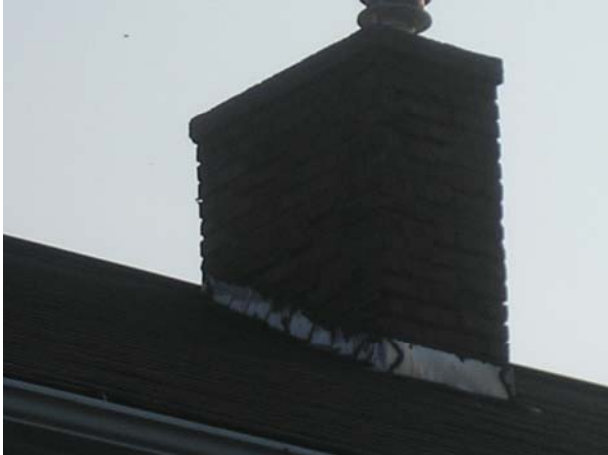
- **Improve:** The masonry chimney is in need of re-pointing (replacing the mortar between the bricks).

- **Improve:** A rain cap and vermin screen should be installed on the masonry chimney.

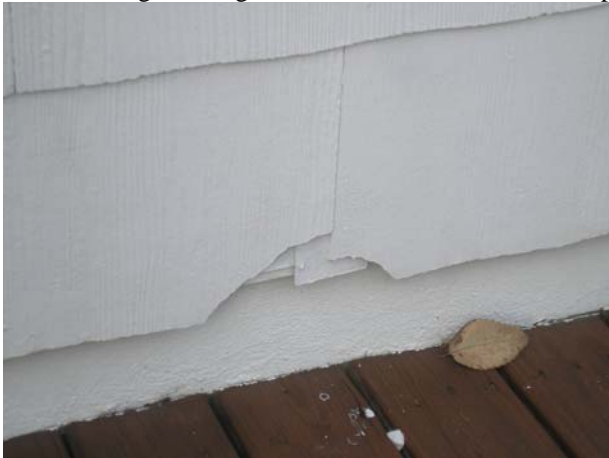
- **Improve:** Damaged siding in various locations should be repaired or replaced as needed.

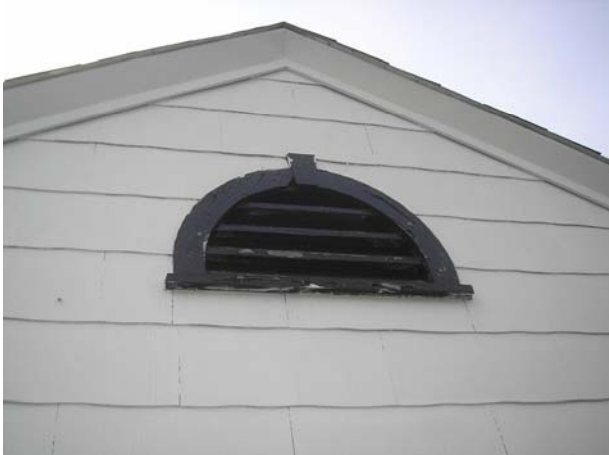
- **Improve:** The exterior wood trim surfaces of the home should be prepped and painted as needed.

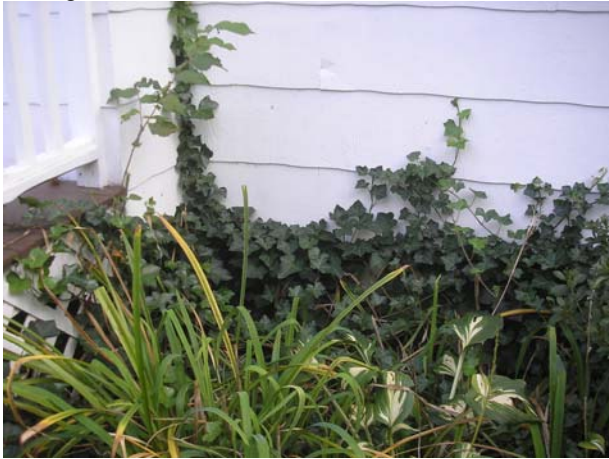
- **Improve:** Vegetation growing on or within 6 inches of exterior walls in various locations should be kept trimmed away from siding, window trims, and the eaves.

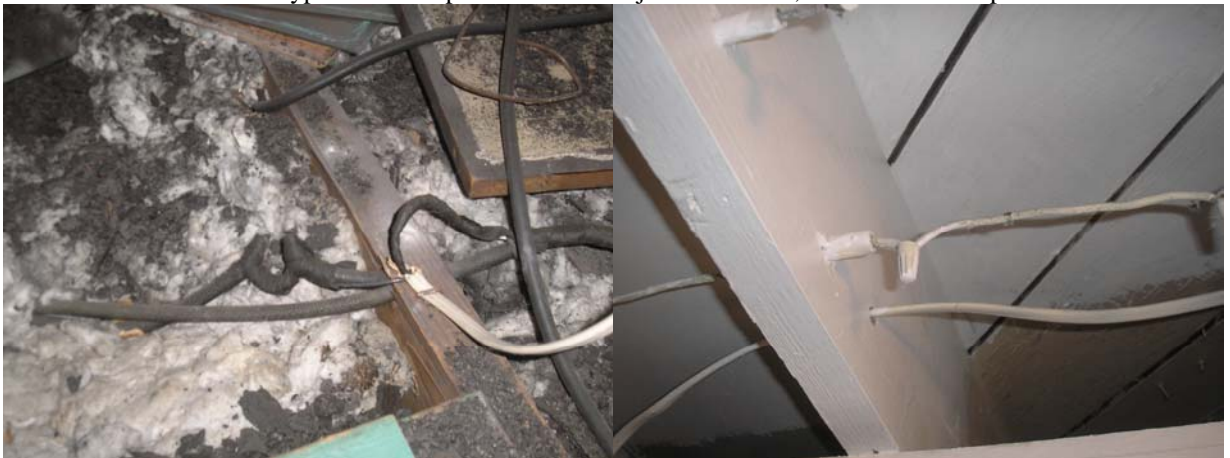
- **Monitor:** Older knob and tube wiring was visible throughout the home. Care should be taken when working with this type of wiring. Insulation should not be permitted to cover this wiring. During any planned renovation, it may be wise to consider replacement of this wiring.
- **Improve:** Poor connections between newer wiring and the older knob-and-tube wiring were observed throughout the home. All connections of this type should be performed within junction boxes, fitted with cover plates.

- **Improve:** Any knob-and-tube wiring that is exposed during renovations should be replaced.

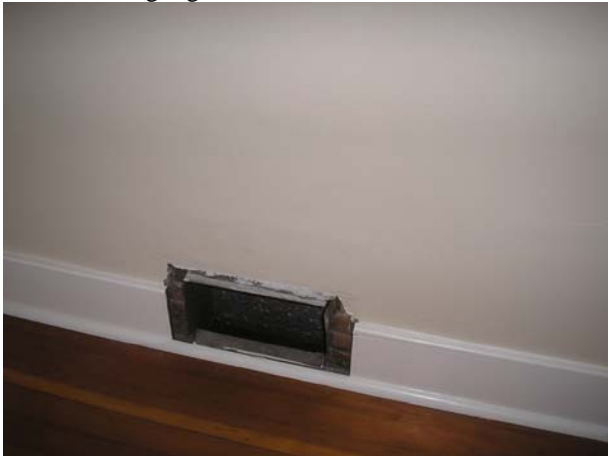
- **Improve:** Heating registers in various locations are loose or missing. It is recommended that they be properly secured.

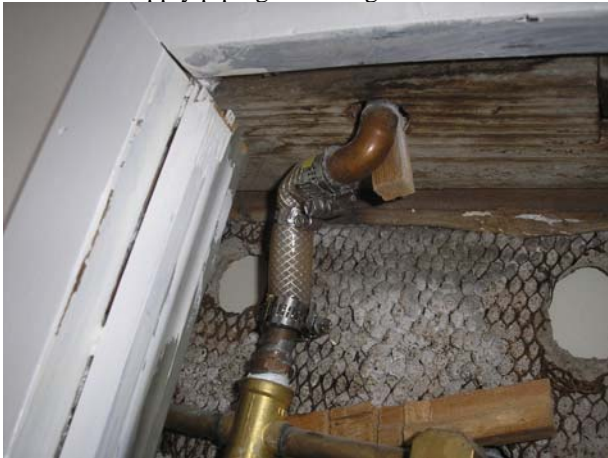
- **Improve:** The supply piping is leaking at the bath tub.

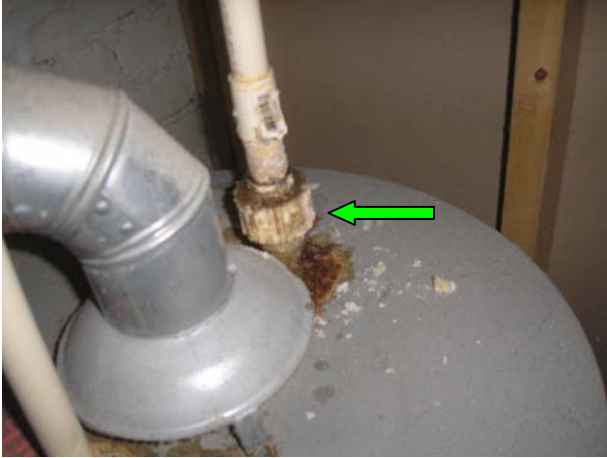
- **Improve:** The supply piping is leaking at the water heater supply.

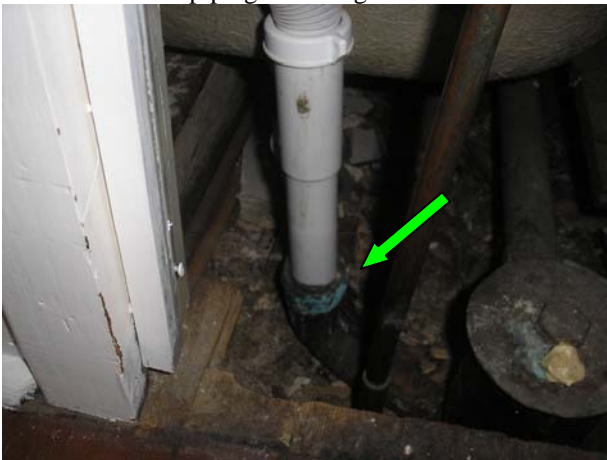
- **Improve:** The waste piping is leaking at the bath tub waste line.

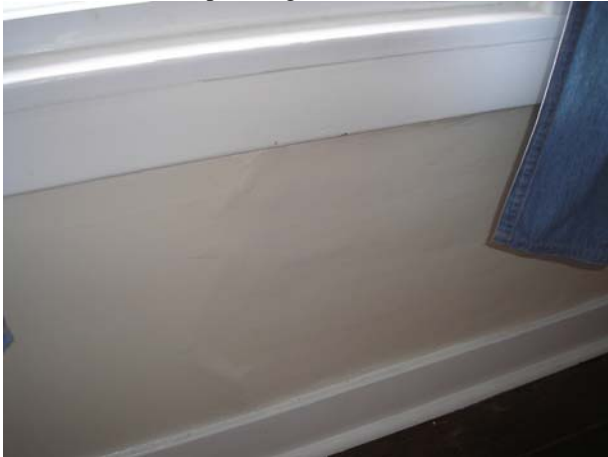
- **Monitor:** Evidence of patching was detected in various locations.

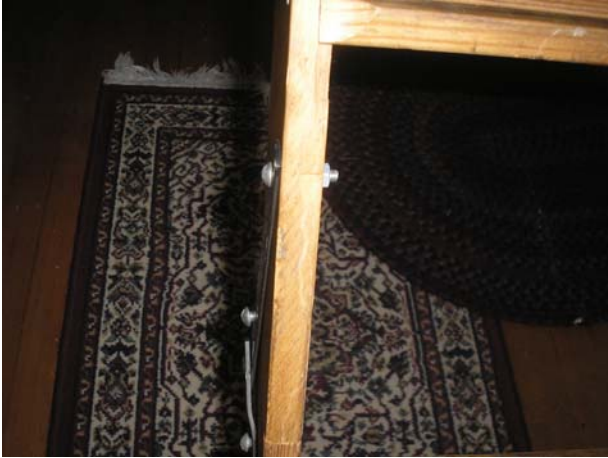
- **Improve:** The attic pull-down stairs should be trimmed and adjusted. (Loose hardware)

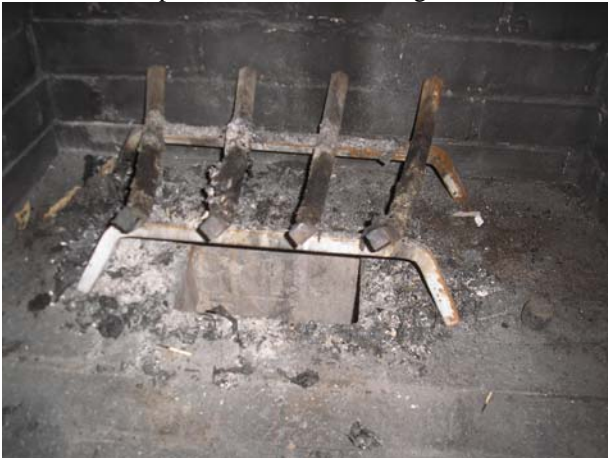
- **Improve:** The fireplace chimney should be inspected and cleaned prior to operation. Once ashes are removed, viewing floor of fireplace for cracks is recommended. If cracks are evident, consulting a contractor for repairs is advisable.
- **Improve:** The hearth outside the fireplace is not large enough to reduce the risk of fire, should hot embers manage to escape from the fireplace. This situation should be altered for improved safety.
- **Improve:** The fireplace firebox mortar should be improved.
- **Improve:** The fireplace ash door is missing.
